**UNION CEMETERY
GEORGETOWN,
MASSACHUSETTS**

**PRESERVATION AND MANAGEMENT
PLAN:**

**GRAVESTONE/MONUMENT
CONDITION ASSESSMENT
REPORT
2008**

**PREPARED FOR THE
GEORGETOWN HISTORICAL COMMISSION
By The Fannin-Lehner Preservation Consultants**

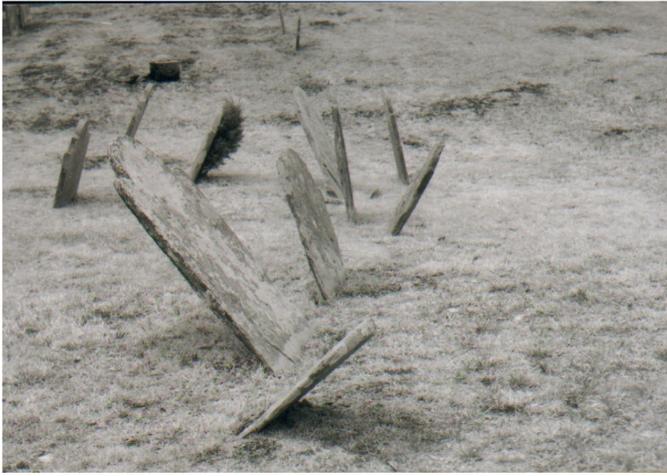
Fannin•Lehner
 271 Lexington Road
 Concord, MA 01742
 Union Cemetery
 Georgetown, MA - 4/9/08
 Roll: 1 Photo: 15

Line of tilted stones beg. w/ Jane Pingry d. 9/13/1735 sec. 1 60

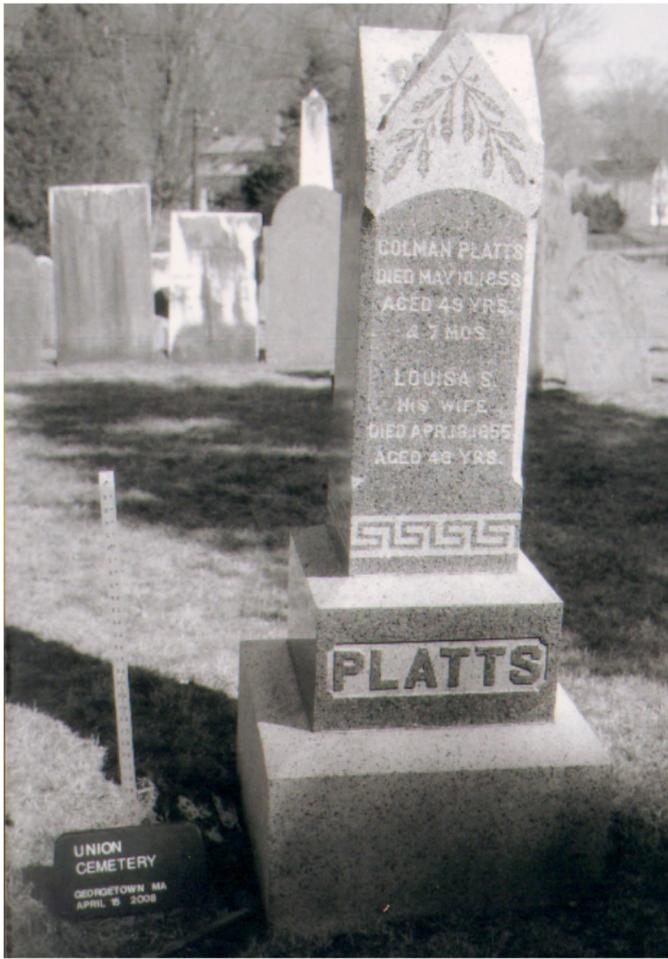
Fannin•Lehner
 271 Lexington Road
 Concord, MA 01742
 Union Cemetery
 Georgetown, MA - 4/15/08
 Roll: 2 Photo: 16

*Platts, Coleman d. 5/10/1853
 Louisa S. d. 4/18/1855
 sec. 2 plot 3
 ex. Tilted mon.*

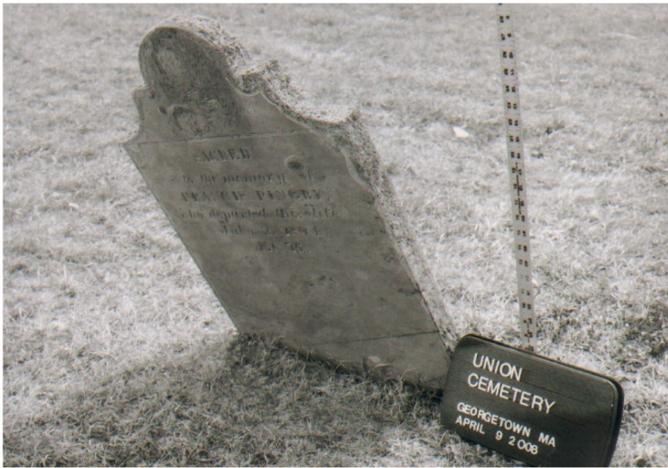
Fannin•Lehner
 271 Lexington Road
 Concord, MA 01742
 Union Cemetery
 Georgetown, MA - 4/9/08
 Roll: 1 Photo: 9

*Francis Pingry d. 7/2/1804
 sec. 1 49
 ex. tilted*

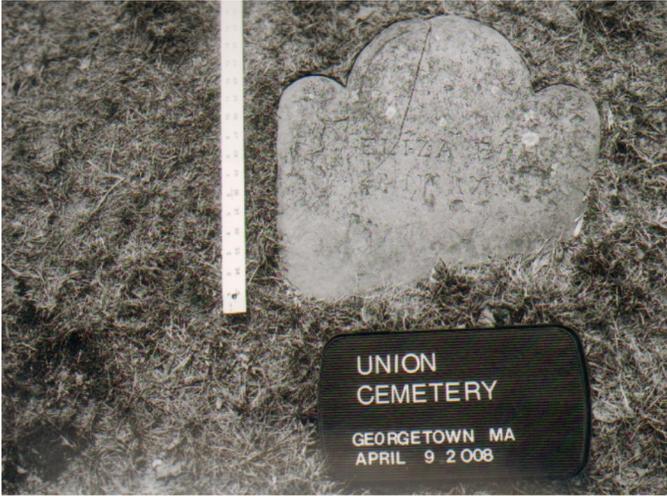
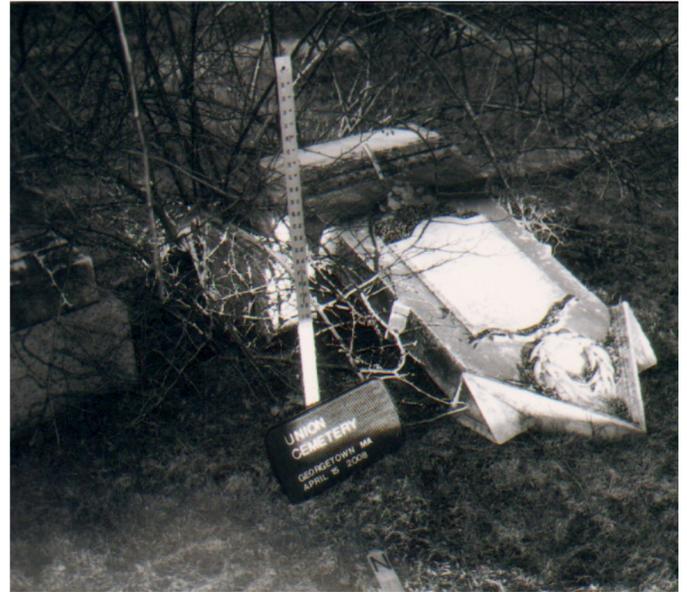
Fannin•Lehner
 271 Lexington Road
 Concord, MA 01742
 Union Cemetery
 Georgetown, MA - 4/9/08
 Roll: 1 Photo: 6

David M. Winter
d. 1/5/1871
Sec. 2 plot 7

ex: Fallen - Shrub impact

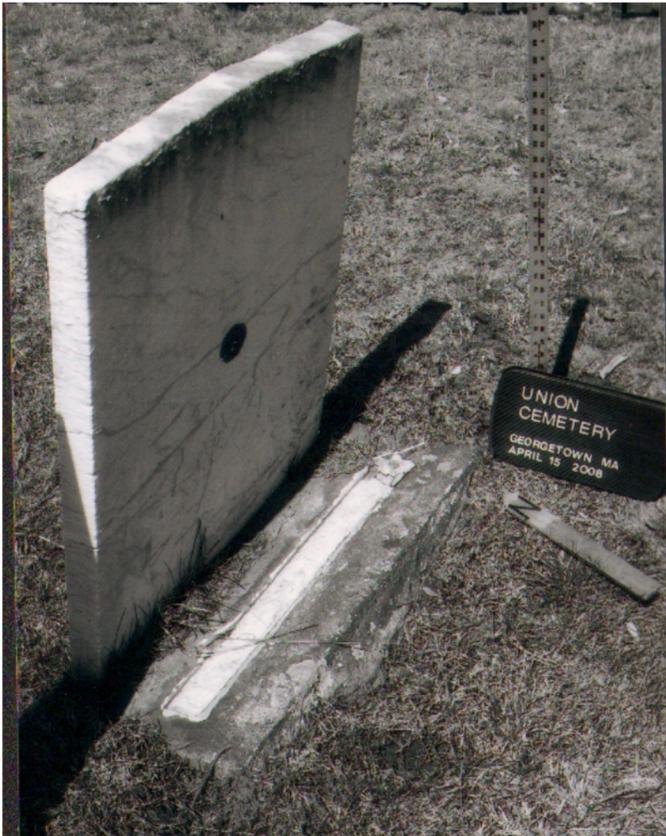
Fannin•Lehner
 271 Lexington Road
 Concord, MA 01742
 Union Cemetery
 Georgetown, MA - 4/15/08 (1783-1883 Addendum)
 Roll: 2 Photo: 9

Benjamin Adams
d. 1/2/1852
Sec. II: # 296

ex: Stone broken at slot

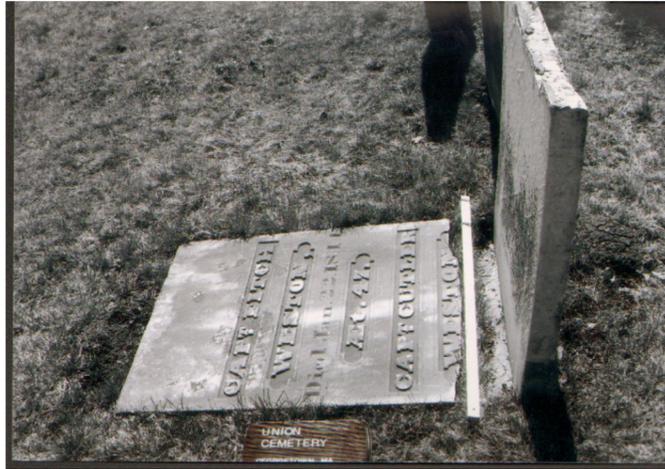
Fannin•Lehner Weston - Capt. Fitch
 271 Lexington Road d. 1/22/1844
 Concord, MA 01742 Capt. Cutler d. 12/1/1834
 Union Cemetery section II: #266
 Georgetown, MA - 4/15/08 (1783-1855 Addendum)
 Roll: 2 Photo: 13
 ex: broken/failed prev. repair

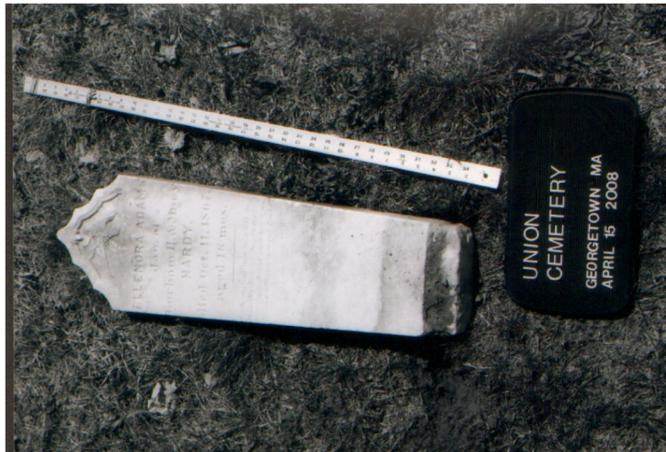
Fannin•Lehner Ellenora Adams
 271 Lexington Road Hardy
 Concord, MA 01742 d. 10/17/1867
 Union Cemetery section II: #294
 Georgetown, MA - 4/15/08 (1783-1855 Addendum)
 Roll: 2 Photo: 10
 ex: Fallen - out of base

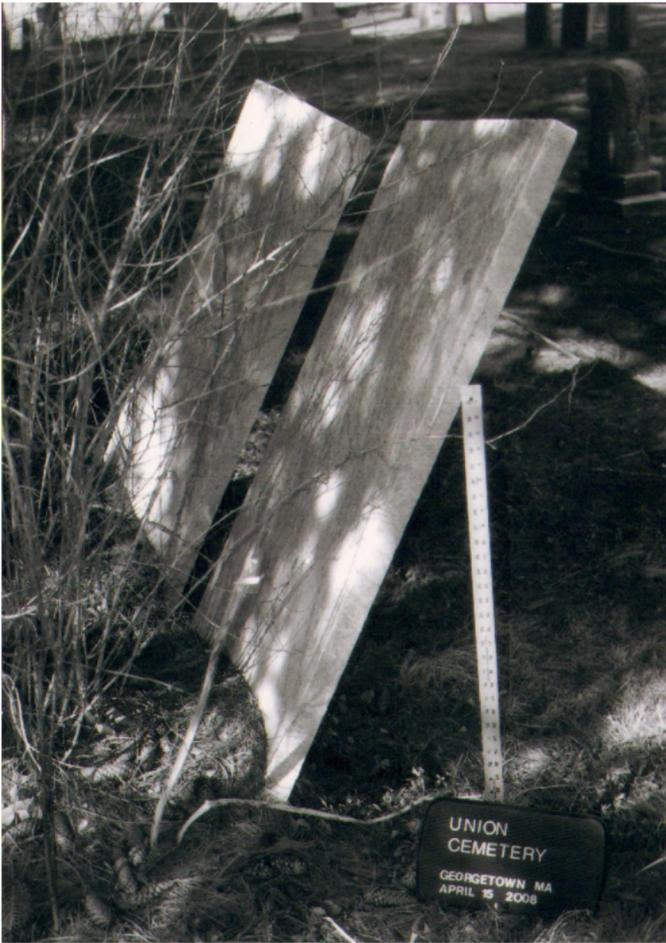
Fannin•Lehner
 271 Lexington Road
 Concord, MA 01742
 Union Cemetery
 Georgetown, MA - 4/15/08

Dole - Sophia Ann
 d. 4/17/1880
 Sophia - d. 2/14/1879
 section II: #54
 (1755-1844)

ex: Tilted / shrub impact

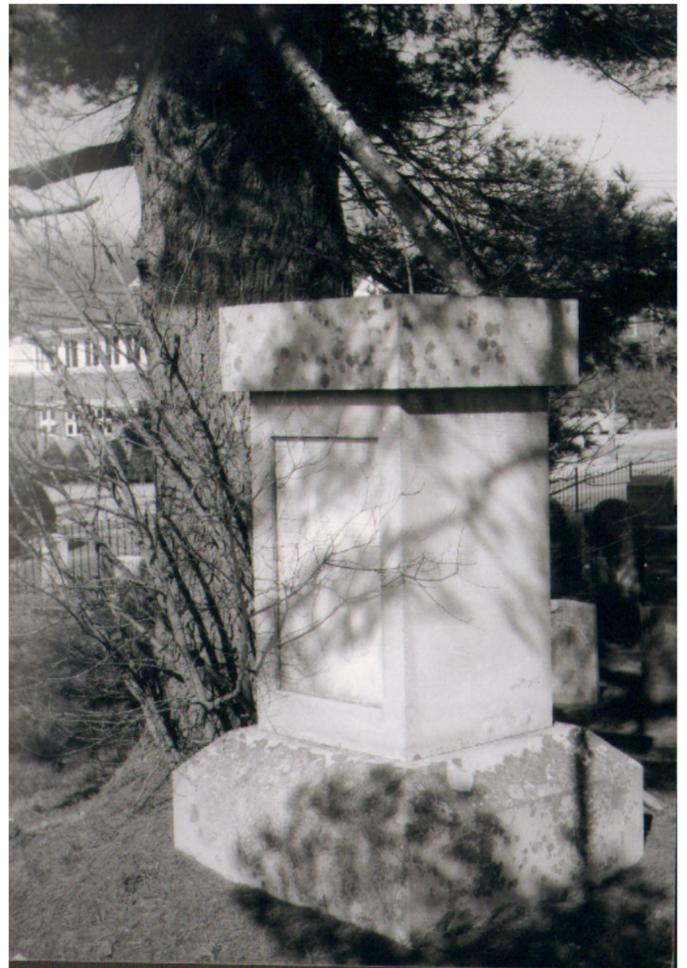
Fannin•Lehner
 271 Lexington Road
 Concord, MA 01742
 Union Cemetery
 Georgetown, MA - 4/15/08

Mighill, Dr. David M.
 d. 5/19/1851 L.L.D.
 Elizabeth m. d. 12/20/1848
 section II: #84/85
 (1755-1844)

MRKR #	LAST NAME	FIRST NAME	DATE OF D	TYPE	MATERIAL	TREATMENT	NOTES/CARVER	PR/COMP
084-85	MIGHILL	DR. DAVID ELIZABETH	MAY 19, 1851 DEC. 20, 1848	MON	GRANITE/ MARBLE	MONITOR FOR TREE INPACT. CLEAN.	EXTENSIVE LICHEN/PITCH	2
					TABLET ON FRONT.			
086	BROWN	WILLIAM J. (FATHER)	SEPT. 30, 1895	MON	MARBLE	DISASSEMBLE. EXCAVATE BASE. CLEAN. RESET BASE.REASSEMBLE AND REPIN	TILTED/ LOOSE ON BASE	1
087	MERRILL	EUNICE DODGE	JAN. 1, 1863	HEAD	MARBLE	EXCAVATE BASE FRAGMENT WITH BASE. REMOVE PREVIOUS REPAIR. CLEAN. RESET BASE FRAGMENT AND BASE DRILL AND PIN UPPER FRAGMENTS. INFILL (MAY NEED NEW BASE)	BROKEN/FALLEN	1
087	MERRILL	BENJAMIN	OCT. 30, 1853	FOOT	MARBLE	CLEAN. RESET DIRECTLY BEHIND HEADSTONE FACING EAST	LOOSE IN GROUND	1
087	N.	J.	N/A	FOOT	MARBLE	FIND PROPER LOCATION. CLEAN. RESET FACING EAST	OUT OF LOCATION FALLEN (FOUND IN LOT 087)	1
088	HARDY	DEACON NEWMAN B. (FATHER)	JUNE 11, 1877	MARKER	MARBLE	EXCAVATE DIE AND BASE. CLEAN. RESET BASE. REPIN	FALLEN	1

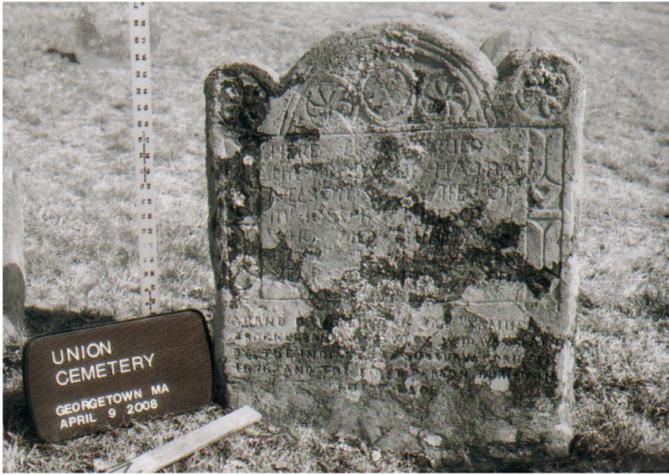
Fannin•Lehner
271 Lexington Road
Concord, MA 01742
Union Cemetery
Georgetown, MA - 4/9/08
Roll: 1 Photo: 21

Hannah Nelson
d. 6/5/1732
sec. 1 28

ex: Heavy bio. growth

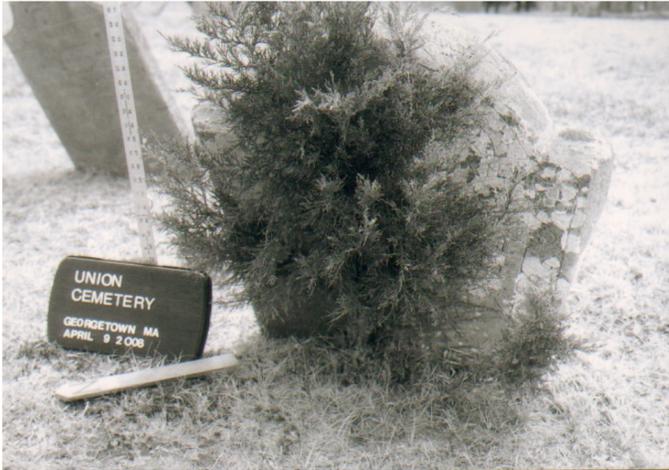
Fannin•Lehner
271 Lexington Road
Concord, MA 01742
Union Cemetery
Georgetown, MA - 4/9/08
Roll: 1 Photo: 10

Mrs. Sarah Hardy
d. 5/22/1767
sec. 1 50

ex: Volunteer shrub

MRKR #	LAST NAME	FIRST NAME	DATE OF D	TYPE	MATERIAL	TREATMENT	NOTES/CARVER	PR/COMP
50	HARDY	MRS. SARAH	MAY 22, 1767	HEAD	SLATE	REMOVE BUSH! EXCAVATE. CLEAN. RESET. STABILIZE LOOSE FRAGMENTS ON FACE	TILTED/ DELAMINATING	1
51	PINGRY	MRS. ELIZABETH	APR. 8, 1816	HEAD	SLATE	EXCAVATE. CLEAN. RESET	TILTED	1
52	SPOFFORD	MRS. ELIZABETH	JAN. 30, 1777	HEAD	SLATE	EXCAVATE. CLEAN. AD REP, RESET, INFILL	BROKEN/TILTED CARVER: CALEB/JOSEPH LAMSON	1
54	ROGERS	MR. NATHAN	OCT. 17, 1813	HEAD	SLATE	EXCAVATE. CLEAN. RESET, AD REP, INFILL	TILTED/ SMALL DELAMINATION	1
55	SPAFFORD	MR. SAMUEL	JAN. 1, 1743	HEAD	SLATE	CLEAN. TACK, CAP. STABILIZE LOOSE FRAGMENTS ON BACK	DELAMINATING/ HEAVY BIOLOGICAL GROWTH	1
58	PINGRY	ELISABETH	JAN. 16, 1747	HEAD	SLATE	EXCAVATE. CLEAN. NEW BASE. SET BASE. MORTAR INTO BASE. TACK, CAP	BROKEN/TILTED/ DELAMINATING	1
59	PENGRY	JOB	AUG. 14, 1736	HEAD	SLATE	EXCAVATE. CLEAN. RESET. TACK, CAP	TILTED/ SMALL DELAMINATION HEAVY BIOLOGICAL GROWTH	1

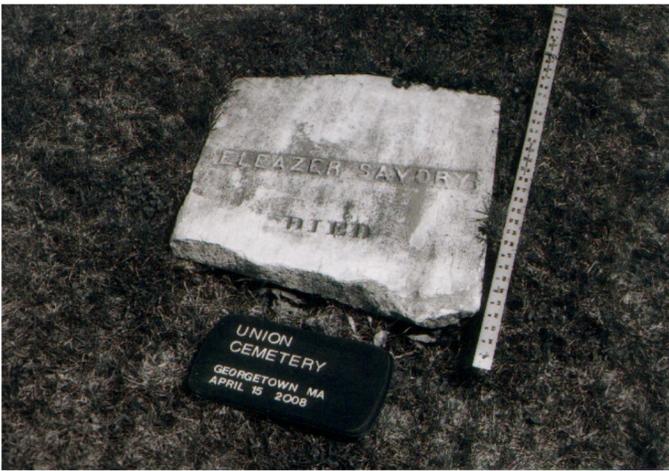
Fannin•Lehner
271 Lexington Road
Concord, MA 01742
Union Cemetery
Georgetown, MA - 4/15/08
Roll: 2 Photo: 12

ex: Head top fragment

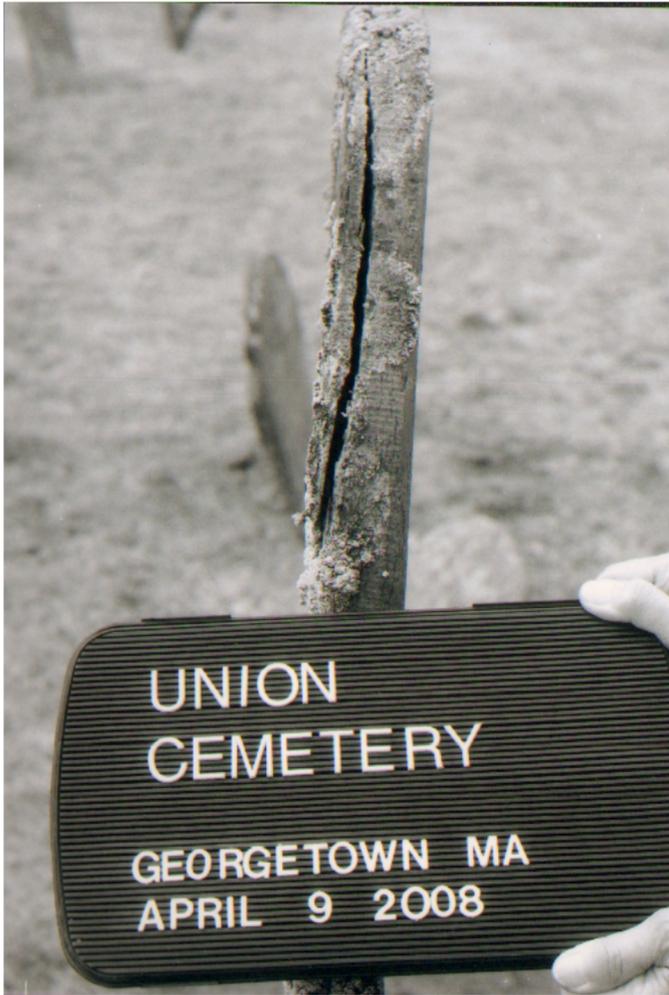
Fannin•Lehner
 271 Lexington Road
 Concord, MA 01742
 Union Cemetery
 Georgetown, MA - 4/9/08
 Roll: 1 Photo: 16

Col. Daniel Spafford
 d. 4/26/1823
 Sec. 1 73

ex: delaminating

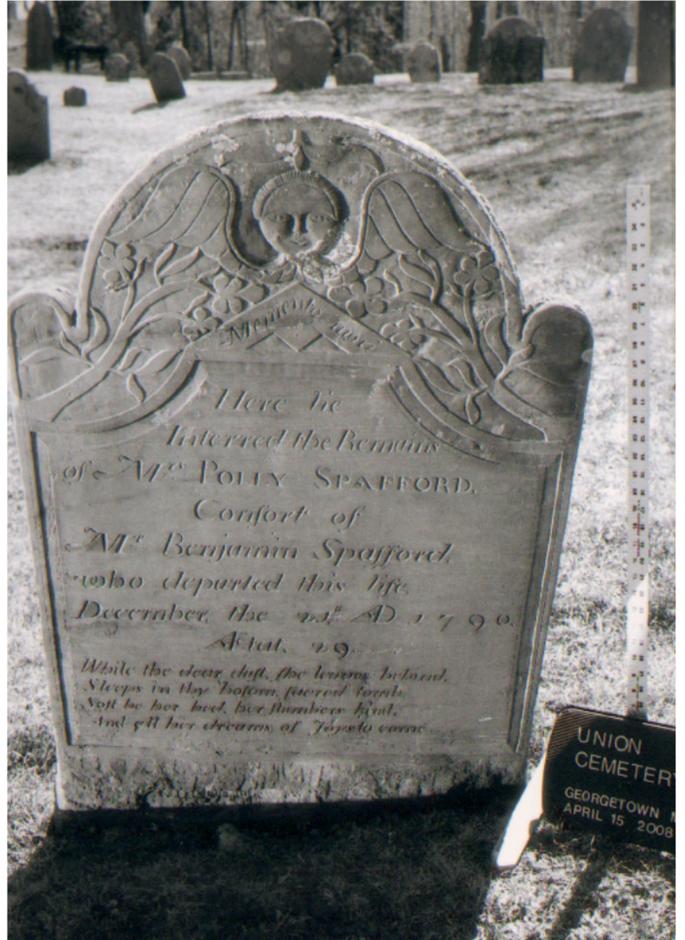
Fannin•Lehner
 271 Lexington Road
 Concord, MA 01742
 Union Cemetery
 Georgetown, MA - 4/15/08
 Roll: 2 Photo: 5

Mrs. Polly Spafford
 d. 12/21/1790
 Sec. 1 103

ex: raised stone

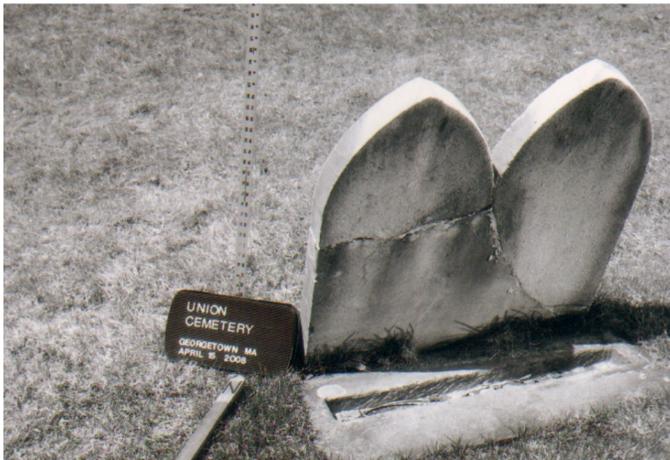
Abel Spofford
d. 1/12/1868
Mary Merrill
d. 8/18/1869
Sec. 2 (Add.) 282
(Addendum)
ex: Fallen - out of base

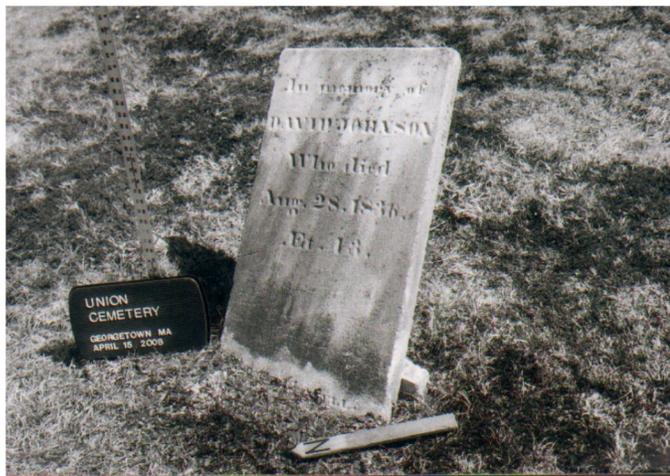
David Johnson
d. 8/28/1836
Sec. 1 107
ex: broken

MRKR #	LAST NAME	FIRST NAME	DATE OF D	TYPE	MATERIAL	TREATMENT	NOTES/CARVER	PR/COMP
106	SPOFFORD	MRS. MARY	FEB. 1, 1802	HEAD	SLATE	EXCAVATE. CLEAN. RESET	TILTED/SUNKEN	1
107	JOHNSON	DAVID	AUG. 28, 1836	HEAD	MARBLE	EXCAVATE BOTTOM FRAGMENT. CLEAN. RESET BOTTOM FRAGMENT. DRILL AND PIN. INFILL	BROKEN CARVER: B. DAY, LOWELL	1
108	ILLEGIBLE	N/A	?? 3, 178?	HEAD BOTTOM FRAG	SLATE	EXCAVATE.CLEAN. RESET	TILTED. "THE 3d 178? IN THE 22D YEAR OF HIS AGE."	2
109	NELSON	MRS. MARY	JULY 22, 1753	HEAD	SLATE	EXCAVATE. CLEAN. NEW BASE. MORTAR INTO BASE. AD REP OF EDGES. CAP	TILTED/ DELAMINATING/ LOOSE IN GROUND	1
110	JAQUES	MRS. MARY	MAY 11, 1760	HEAD	SLATE	EXCAVATE.CLEAN. RESET. TACK,CAP	TILTED/RAISED	1
111	PINGRY	DAVID HILEMON	MAY 1, 183?	HEAD	MARBLE	EXCAVATE. BOTTOM FRAGMENT IS 2 1/2" BELOW GRADE. CLEAN. DRILL & PIN. NEW BASE? RESET BASE,MORTAR INTO BASE	BROKEN/TILTED	1
115	PINGREE	MARY PERKINS	APR. 14, 1841	HEAD	MARBLE	EXCAVATE.CLEAN, RESET	TILTED	1

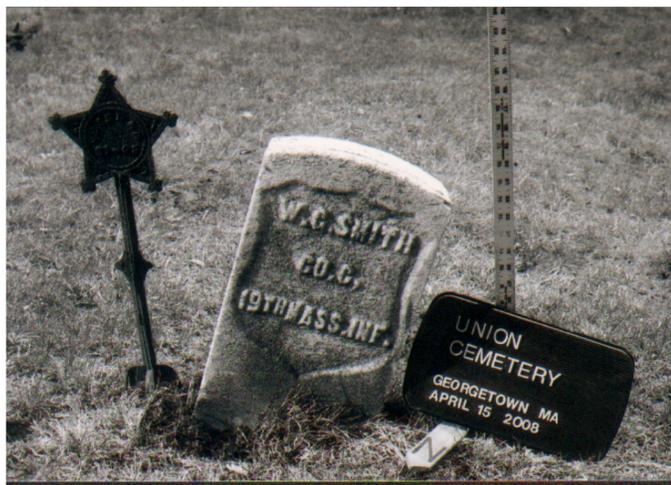
W.G. Smith
sec. 1 116
ex: military marker

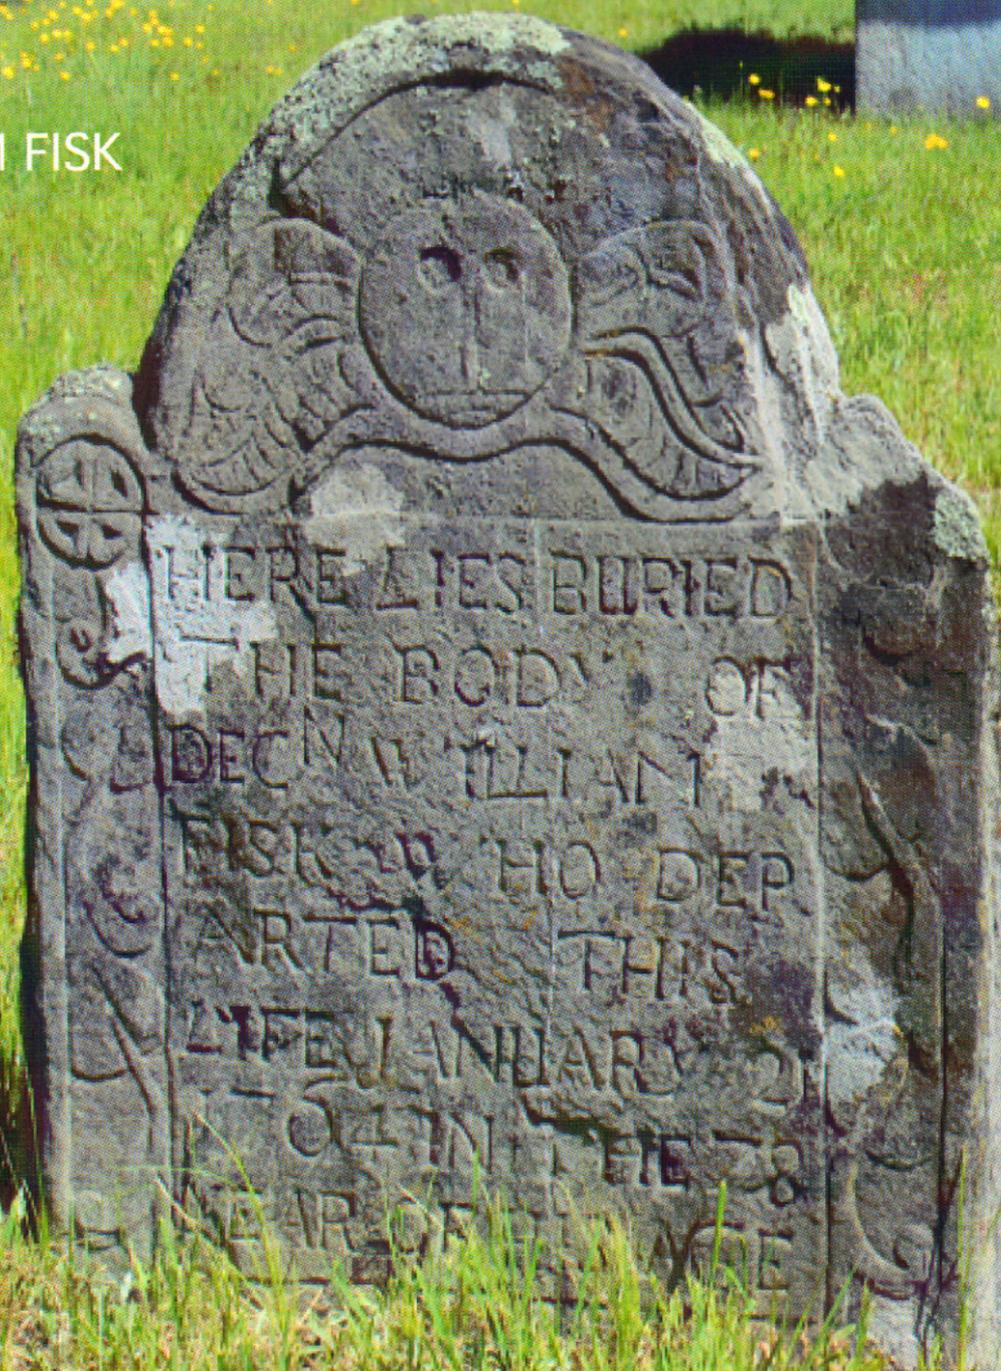
DEACON WILLIAM FISK
d. 1764

CARVER: JOSEPH
MULLIKEN

HERE LIES BURIED
THE BODY OF
DECN WILLIAM
FISK WHO DEP
ARTED THIS
LIFE JANUARY 21
1764 IN THE 78
YEAR OF HIS AGE

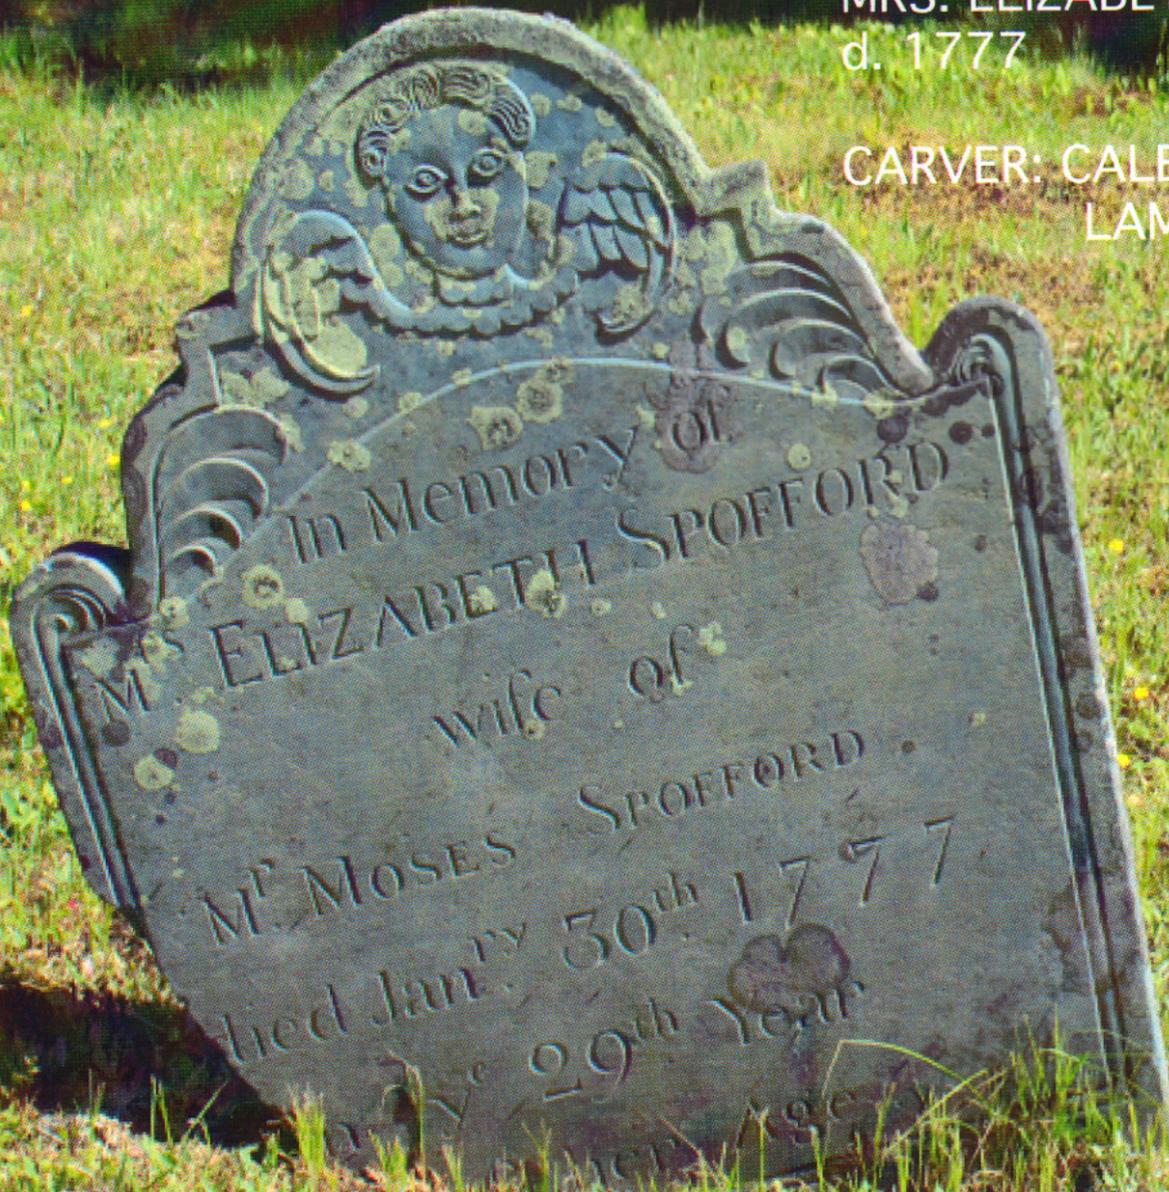
MRS. ELIZABETH SPOFFORD
d. 1777

CARVER: CALEB OR JOSEPH
LAMSON

In Memory of
MRS. ELIZABETH SPOFFORD
wife of
MR. MOSES SPOFFORD
died Jan. 30th 1777
aged 29th Year

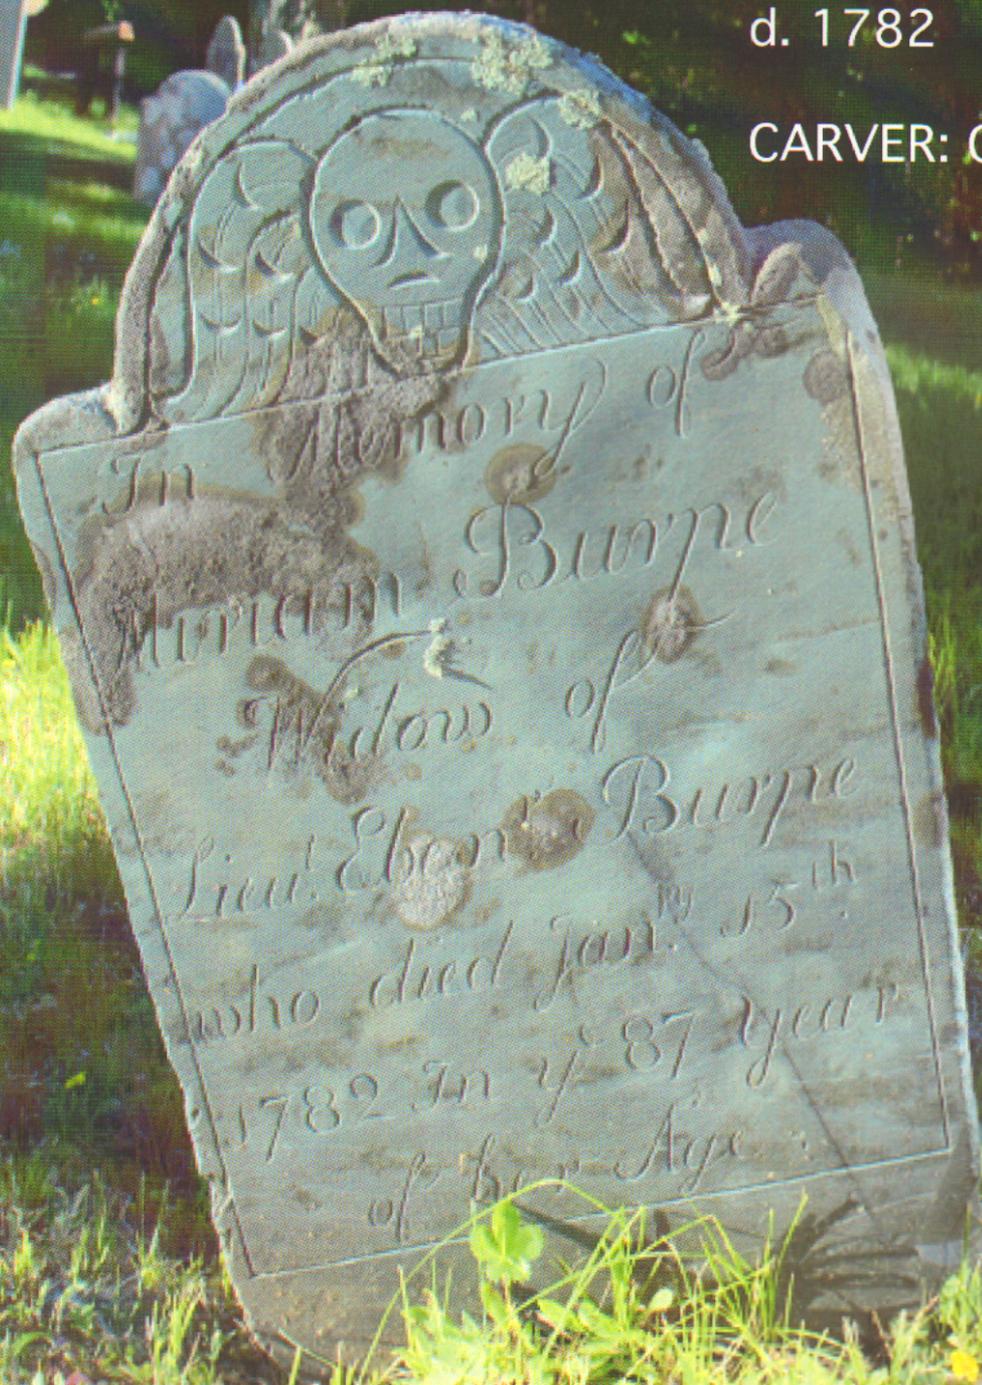
MIRIAM BURPE
d. 1782

CARVER: CALEB LAMSON

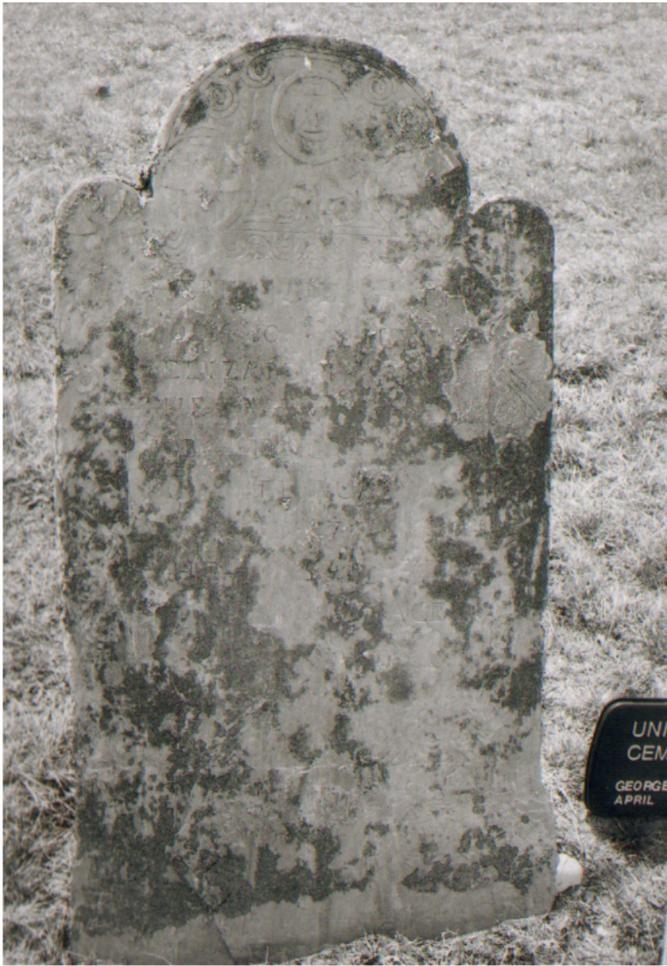
Fannin•Lehner
 271 Lexington Road
 Concord, MA 01742
 Union Cemetery
 Georgetown, MA - 4/9/08
 Roll: 1 Photo: 5

Elizabeth Pingry
d. 2/11/1747
Sec. 1 61
Leiguton
carver: Jonathan a Richard

MRKR #	LAST NAME	FIRST NAME	DATE OF D	TYPE	MATERIAL	TREATMENT	NOTES/CARVER	PR/COMP
61	PINGRE	MRS. ELIZABETH	FEB. 11, 1747	HEAD	SLATE	EXCAVATE. CLEAN. RESET. TACK,CAP. STABILIZE FRAGMENTS ON BACK	TILTED/RAISED/ DELAMINATING CARVER: JONATHAN OR RICHARD LEIGHTON	1
62	PINGRY	MRS. DOROTHY	JAN. 31, 1771	HEAD	SLATE	EXCAVATE. CLEAN. RESET.	TILTED/RAISED	1
63	PINGRY	ELIZABETH	FEB. 11, 1747	FOOT	SLATE	EXCAVATE. CLEAN. NEW BASE. SET BASE BEHIND HEADSTONE #61.MORTAR INTO BASE. TACK,CAP	BROKEN/FALLEN/ DELAMINATING	1
64	PINGRY	MRS. ELISABETH	MAY 21, 1781	HEAD	SLATE	EXCAVATE. CLEAN. RESET. TACK,CAP	TILTED/RAISED/ DELAMINATING	1
65	PINGRY	MR. JOB	APR. 25, 1785	HEAD	SLATE	EXCAVATE. CLEAN. RESET.	TILTED/RAISED CARVER: PARK FAMILY OR JOSEPH MARBLE	2
66	PINGRY	MRS. ELISABETH	MAY 21, 1781	FOOT	SLATE	EXCAVATE. CLEAN. NEW BASE. SET BASE BEHIND HEADSTONE #64. MORTAR INTO BASE	FALLEN/BROKEN	1
67	PINGRY	CLEMENS ENSIGN JOHN JOHN SOLOMON	JUNE 5, 1769 AUG. 30, 1796 OCT. 4, 1778 SEPT. 22, 1773	HEAD	SLATE	EXCAVATE. CLEAN. RESET	TILTED/RAISED	1

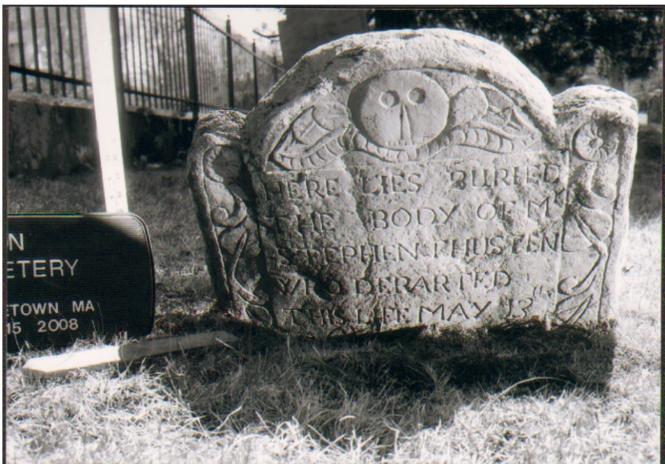
Fannin•Lehner
 271 Lexington Road
 Concord, MA 01742
 Union Cemetery
 Georgetown, MA - 4/15/08
 Roll: 2 Photo: 6

Mr. Stephen Thurston
d. 5/13/1762
Sec. 1 104
carver: Joseph Mullicker

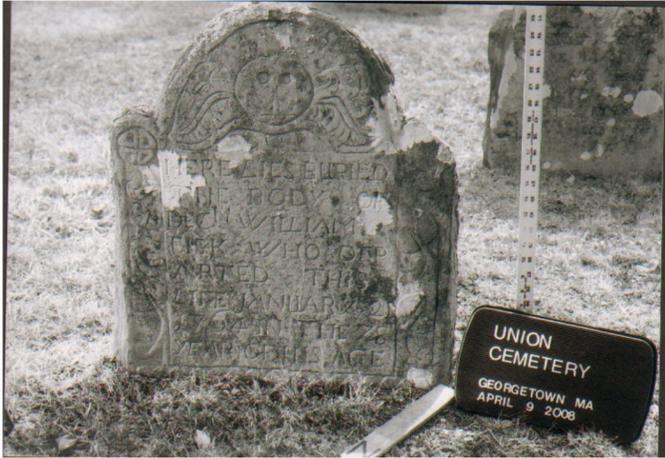
Fannin•Lehner
 271 Lexington Road
 Concord, MA 01742
 Union Cemetery
 Georgetown, MA - 4/9/08
 Roll: 1 Photo: 14

Dea. William Fisk
d. 1/21/1767
Sec. 172
Cover: Probably Joseph Mullicken

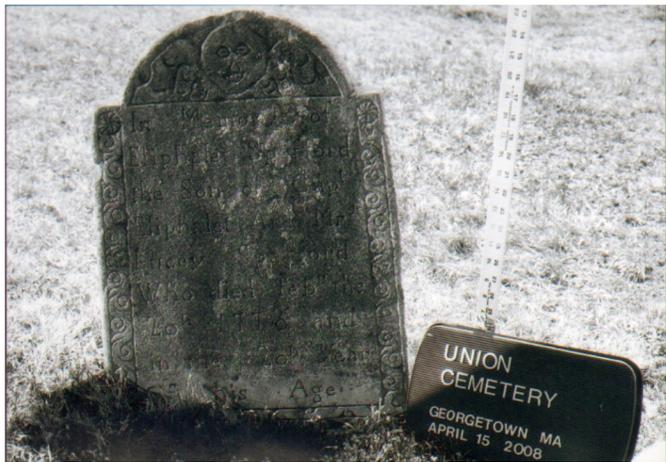
Fannin•Lehner
 271 Lexington Road
 Concord, MA 01742
 Union Cemetery
 Georgetown, MA - 4/15/08
 Roll: 2 Photo: 2

Eliphaz Spofford
d. 2/20/1776
Sec. 185
Cover: Joseph Mauble

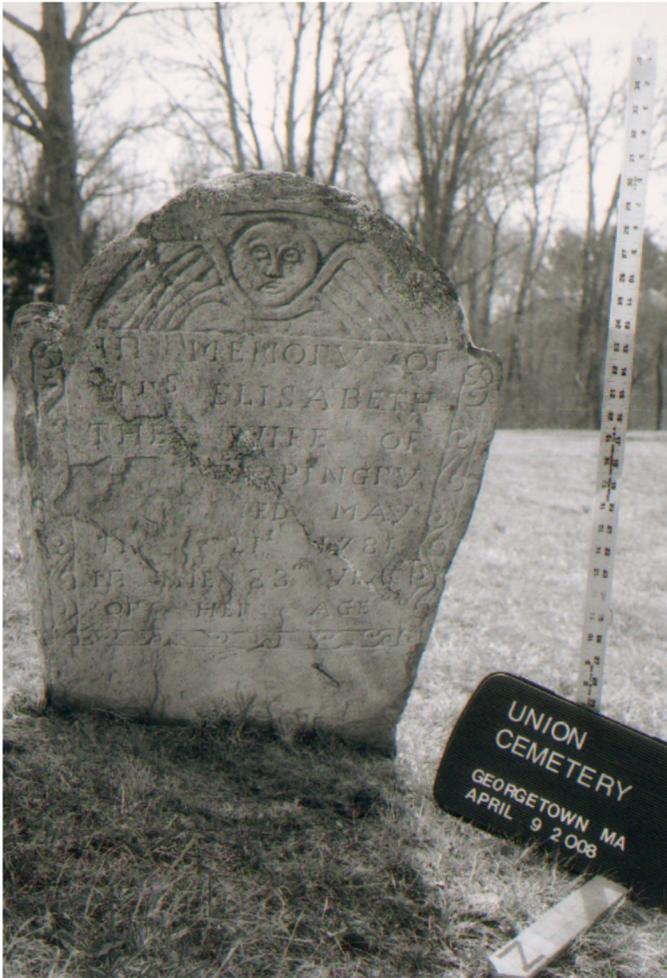
Fannin•Lehner
 271 Lexington Road
 Concord, MA 01742
 Union Cemetery
 Georgetown, MA - 4/9/08
 Roll: 1 Photo: 7
carver: unknown

Handwritten: Mrs. Elisabeth Pingry
 d. 5/2/1781
 sec. 1 64

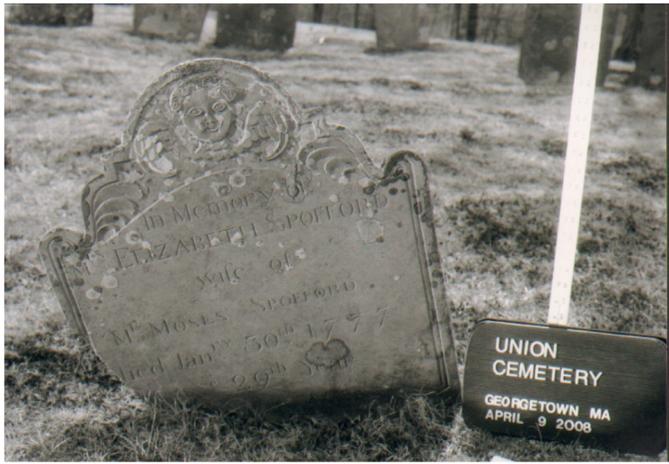
Fannin•Lehner
 271 Lexington Road
 Concord, MA 01742
 Union Cemetery
 Georgetown, MA - 4/9/08
 Roll: 1 Photo: 3
carrier: Caleb or Joseph Lanson

*Mrs. Elizabeth Spofford
 d. 1130, 1777
 Sec. 1 52*

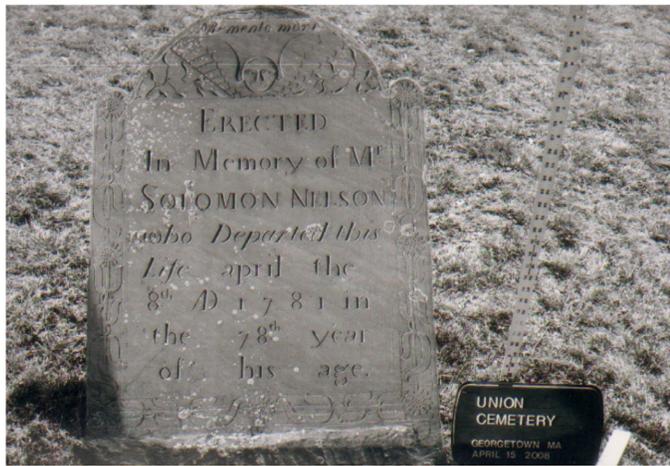
Fannin•Lehner
 271 Lexington Road
 Concord, MA 01742
 Union Cemetery
 Georgetown, MA - 4/15/08
 Roll: 2 Photo: 0
carrier: Probably Joseph Marble

*Mr. Solomon Nelson
 d. 4/8/1781
 Sec. 1 96*

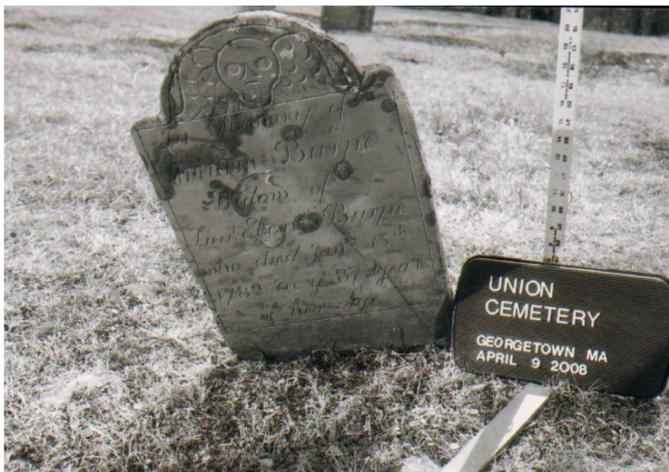
Fannin•Lehner
 271 Lexington Road
 Concord, MA 01742
 Union Cemetery
 Georgetown, MA - 4/9/08
 Roll: 1 Photo: 4
carrier: Probably Caleb Lanson

*Miriam Burpe
 d. 1151, 1782
 Sec. 1 33*

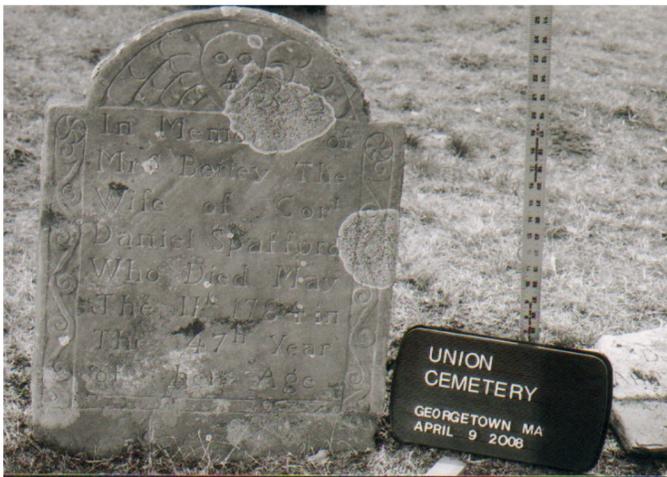
Fannin•Lehner
271 Lexington Road
Concord, MA 01742
Union Cemetery
Georgetown, MA - 4/9/08
Roll: 1 Photo: 13

Mrs. Betsey Spafford
d. 5/11/184
Sec. 1 75
carrier: Joseph Marble

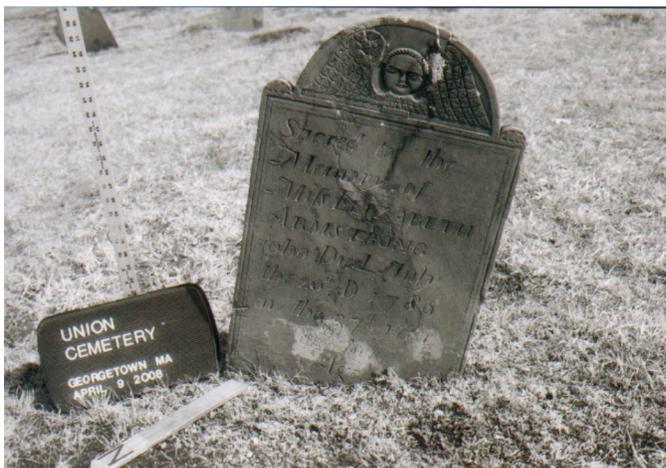
Fannin•Lehner
271 Lexington Road
Concord, MA 01742
Union Cemetery
Georgetown, MA - 4/9/08
Roll: 1 Photo: 20

Miss Elizabeth
Armstrong
d. 7/17/1789
Sec. 1 87
carrier: Probably John
Marble

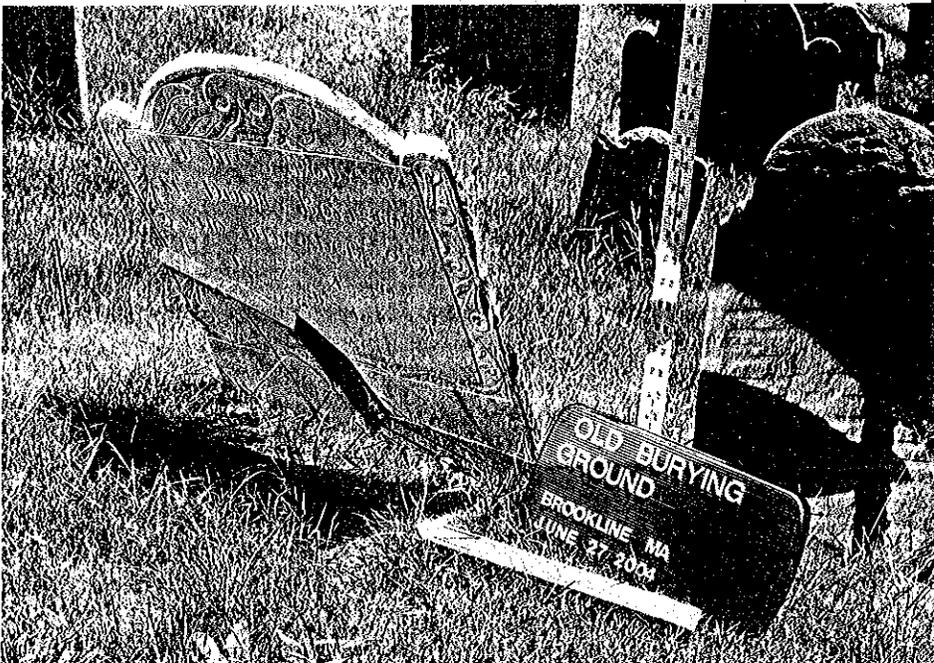
Name: Boylston, Mr. Dudley Date of Death: August 29, 1749 Ref/Sec: 95

Conservation Notes: 6/05 - 1) Headstone excavated and found to have sufficient length to reset. 2) The main fragment and fragment from lower proper right cleaned with water and Photo-Flo. 3) Adhesive repair of top and bottom fragment using Akepox 2010 stone epoxy. Repair clamped. 4) Headstone reset level and plumb in well-compacted sand and peastone.
